Evaluation Report 196

Will-Rich 13CPW (11.3 m) Heavy Duty Cultivator

WIL-RICH 13CPW CHISEL PLOW

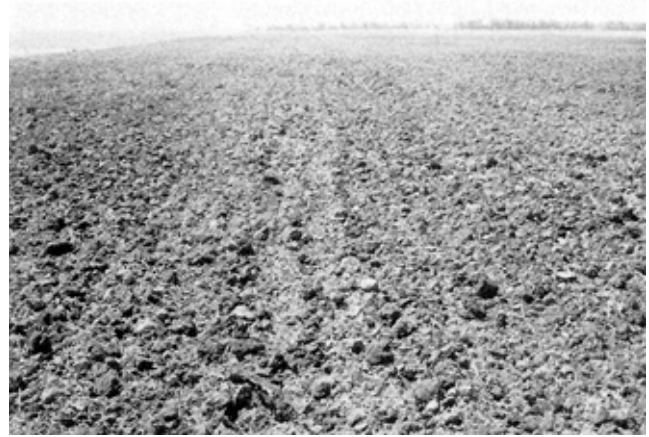
FIGURE 6. Typical Field Surface when using Optional Mounted Harrows.

Functional performance of the optional mounted harrows was fair. The harrows were effective in smoothing out surface ridges, leaving a slightly ridged surface condition (FIGURE 6). In heavy trash conditions, the mounted harrows tended to plug easily.

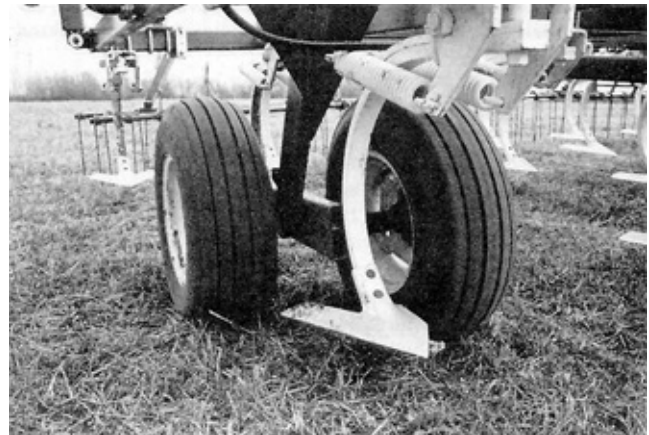
FIGURE 8. Trimmed Sweep.

Skewing and Stability: The Wil-Rich 13CPW skewed considerably on side slopes or in heavy draft conditions where soil varied in hardness across the width of the machine. The sweep pattern (FIGURE 7), however, was symmetrical and did not impose any resultant side forces on the cultivator during normal operation. With 406 mm (16 in) sweeps, as used on 33 of the 37 shanks, the cultivator had to skew more than 2.4° for weed misses to consistently occur across the cultivator width. Trimmed sweeps (FIGURE 8) were used on the 4 shanks adjacent to the wheels, and the cultivator had to skew only minimally for weed misses to occur at these locations. Moderately hilly ground caused sufficient sideways skewing for frequent weed misses by the trimmed sweeps.

Weed Kill: Weed kill was fair in normal soil conditions when the cultivator was equipped with 406 mm (16 in) sweeps at a lateral spacing of 305 mm (12 in). Shanks adjacent to the wheels had trimmed sweeps which gave minimal overlap and frequent weed misses occurred during sideways skewing on uneven ground. Sweeps were located behind the depth control wheels to uproot weeds in the wheel tracks.

It is recommended that shanks be arranged on the cultivator to avoid the use of trimmed sweeps adjacent to wheels.

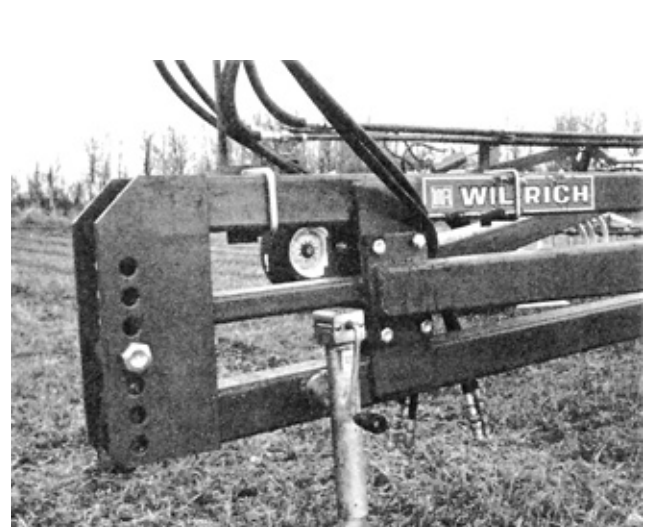
FIGURE 10. Hitch Link in Vertical Position.

The hitch link (FIGURE 10) swivelled downward when not hitched to a tractor, making one man hitching very difficult. It is recommended that a device be provided to hold the link in horizontal position for one man hitching.

The hitch link of the Wil-Rich 13CPW swivelled downward when not hitched to a tractor. In the process of hitching, a safety hazard exists when a person holds the hitch link, while the operator moves the tractor into position. This hazard could be eliminated by use of a device to hold the hitch link in a horizontal position. It is recommended that the manufacturer supply as standard equipment, a device to hold the hitch link in a horizontal position.

10. Supplying an alternate location for the hitch jack at the rear of the cultivator for use when equipped with mounted harrows.
11. Supplying a device to hold the hitch link in the horizontal position to facilitate one-man hitching.

10. An optional rear jack stand assembly is available for use with mounted harrows. Hitching can also be done with the sweeps on the ground.
11. An optional two-bolt heavy duty hitch link is available and facilitates one-man hitching. There has not been adequate demand for a device on the one-bolt hitch link to justify the added cost.

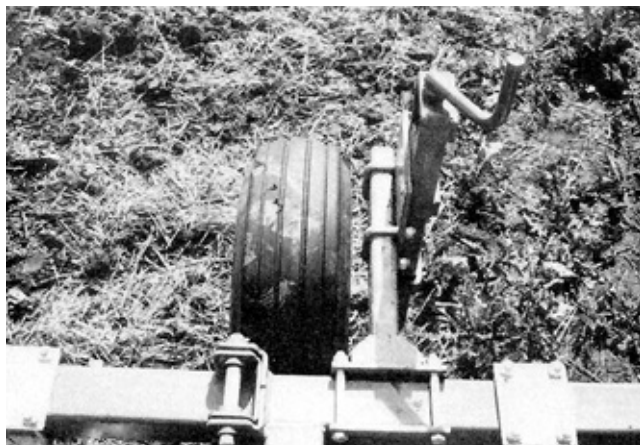
FIGURE 12. Stabilizer Wheel Mount Stub.

Stabilizer Wheels: The stabilizer wheel mount twisted during operation, resulting in moderate wheel misalignment (FIGURE 12). It is recommended that the stabilizer wheel mount stub be strengthened to retain proper wheel alignment during operation.

The stabilizer wheels rubbed on their mounts during operation. It is recommended that the stabilizer axles be extended to give adequate clearance between the wheels and mounts.

1. Improving quality control and set up inspection to guard against frame misalignment.
2. Eliminating interference between the stabilizer wheels and their mounts, and strengthening the mount members to maintain wheel alignment during operation.

2. To accommodate several different installations and clearances, the stabilizer wheel axle assemblies are designed so that they can be mounted in six different ways. Alternate mounting would have eliminated interference. A heavy duty castoring stabilizer wheel is also available.

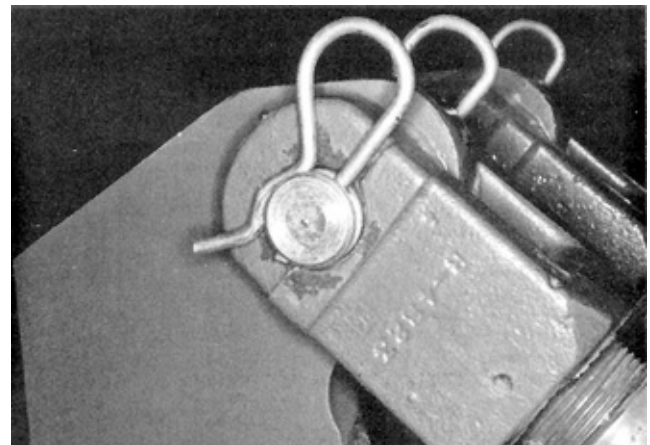
FIGURE 13. Damaged Retainer Clips on Cylinder Yokes.

Pin Retainer Clips: Retainer clip damage was caused by forced rotation of the cylinder pins during operation (FIGURE 13). It is recommended that the pins be firmly anchored in the cylinder yokes to prevent clip damage from rotation.

8. Modifications to reduce pin retainer clip failures on the hydraulic cylinders.
9. Supplying tires which comply with the Tire and Rim Association toad rating.

8. Redesigned hydraulic cylinder yoke pins, which prevent damage to the retainer clips, are in production.
9. Various tire sizes and ratings are available from Wil-Rich. Tires and wheels are supplied according to dealer order. We find the tire and rim association ratings to be quite conservative, but refuse dealer requests when the tire overload is severe.

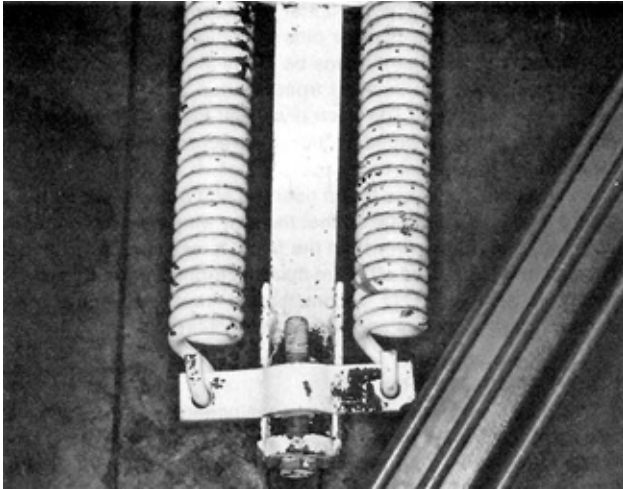
FIGURE 14. Shank Holder Interference with Frame.

Shank Interference: When positioned according to the manufacturer's recommendations, shanks on both wings, when tripped, interfered with diagonal frame members, causing shank holder damage (FIGURE 14). It is recommended that the shanks and frame members be positioned to avoid interference.

3. Modifying the shank holders to reduce breakage.
4. Arranging shanks on the cultivator to avoid use of trimmed sweeps adjacent to wheels, and to avoid interference with frame members.

4. Shank interference with frame members can be avoided by moving the affected shanks laterally by as little as 6 mm (0.25 in). Shank placement practices will be considered on all future major redesigns.

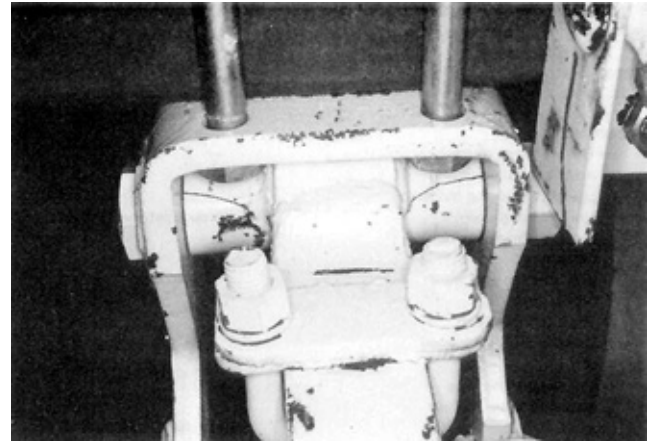
FIGURE 15. Shank Holder Pivot Failures.

Shank Holder Pivot Failures: The pivots of 19 shank holders cracked as shown in FIGURE 15. It is recommended that the pivots be strengthened to prevent such breakage.

3. Failures typical to those experienced by PAMI were traced to a vendor supplying inferior tubing material, which once detected, was immediately corrected. The material specifications have been upgraded and the quality control inspection practices tightened.
